Lonnonson Arbor Care

November 12, 2020

Re: **Tree Inventory Report** for 7303 Renton-Iss Rd, Issaquah (Parcel # 2924069052)

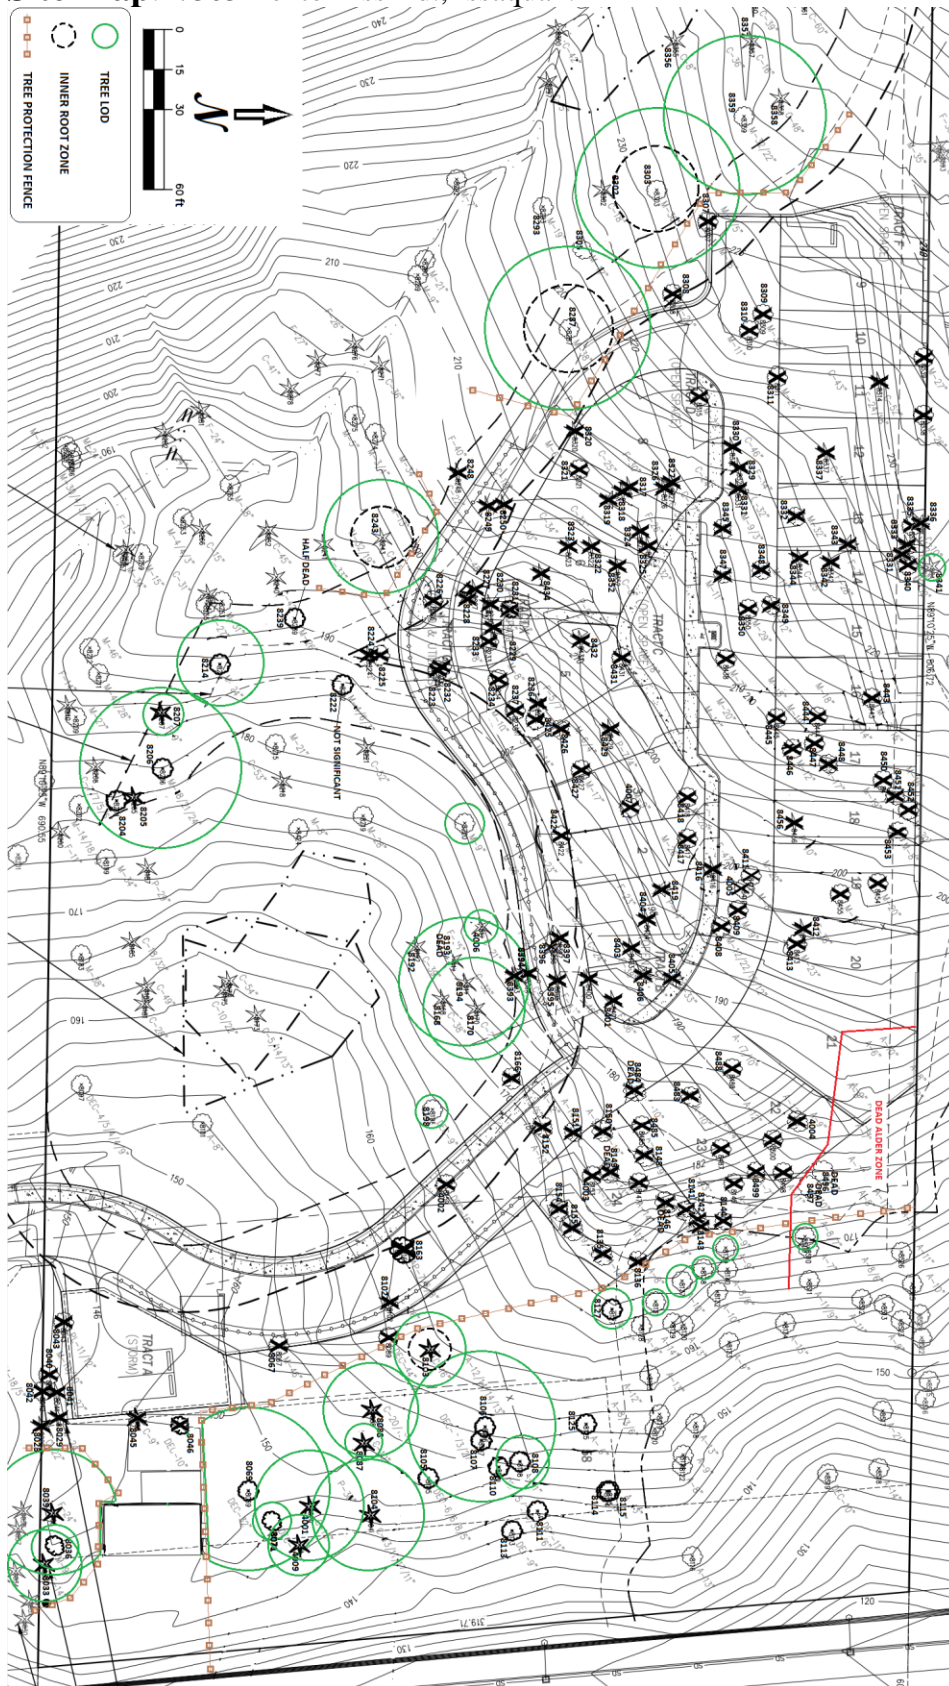
Site Map: 7303 Renton-Issa Rd., Issaquah.

29 retained trees within the buildable areas. This is approximately a 17% retention plan [(29 trees / 171 trees) x 100%] within the buildable areas. In addition, the east side of the property has the most tree diversity.

Protective fencing is required around the perimeters of the LOD for each retained tree, or grove of trees during grading and construction. Chain-link fencing is recommended to protect and preserve the trees from soil disturbance due to machines, foot traffic, and materials. Grading and construction should not be allowed within the LOD of retained trees, unless described in this report. The following site map shows the LODs and recommended placement for protection fencing around retained trees. Signage is recommended on the fence that indicates "Tree Protection Area, Do Not Enter".

I allow the protection fencing to cut across part of the LOD of Cedar trees 8103, 8243, and Maple trees 8303 and 8287 to provide maximum buildable area. This fencing plan disturbs less than 30% of the outer root zone area and protects the inner root zone area. The threshold for outer root zone disturbance is no more than 30% of the area, not including the inner root zone area. The following calculations show the square feet (SF) of allowable disturbance to the outer root zones of trees 8103, 8243, 8303, and 8287.
